TWELVE MONTH PROGRESS REPORT NASA-NAG8-846

CHEMICAL COMPATIBILITY OF CARTRIDGE MATERIALS

R.C. Wilcox and R.H. Zee
Department of Mechanical Engineering
Auburn University, AL 36849-5341
Phone: (205) 844-3323
Fax: (205) 844-3307

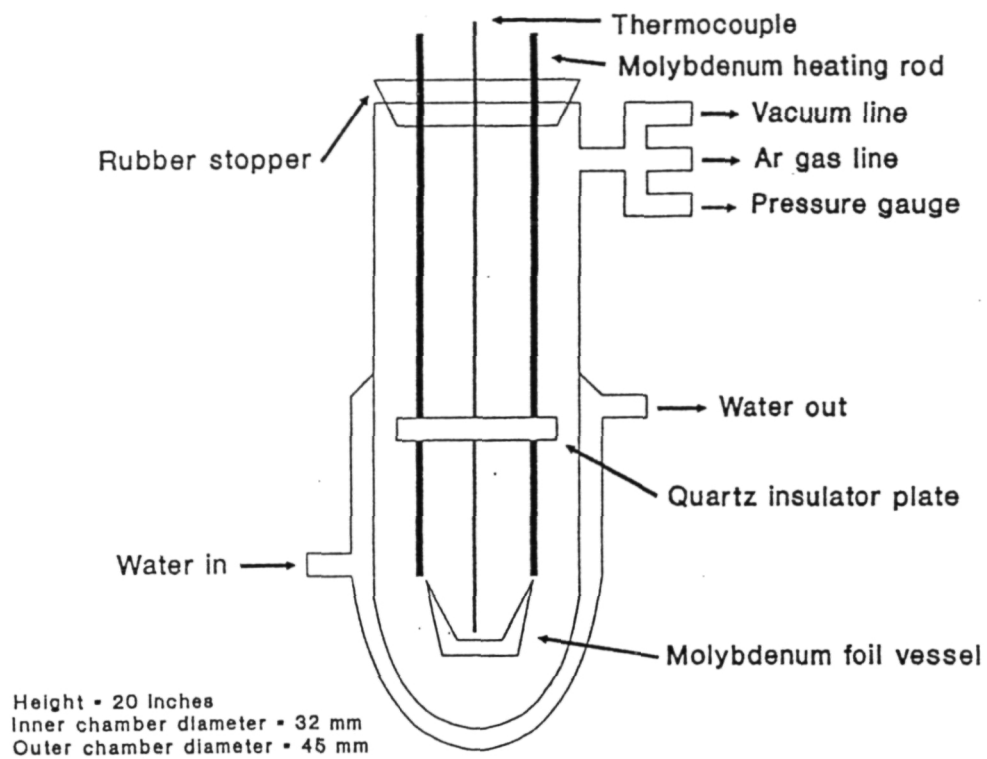
Figure 1. Schematic of GaAs - Mo reaction retort.

The retort was designed so that GaAs could be melted directly in a molybdenum container. The final retort design is shown in Figure 1. The molybdenum container or boat, a 0.5 mm thick foil, was resistance heated by passing an electrical current through 3.175 mm (0.125 in) diameter molybdenum rods connected to the foil. The smaller cross-sectional area of the boat compared to the rods caused resistance heating of the boat. The temperature of the boat was measured by a thermocouple touching the bottom of the boat. The Mo rods were protected from mutual contact by ceramic insulators (Figure 2).

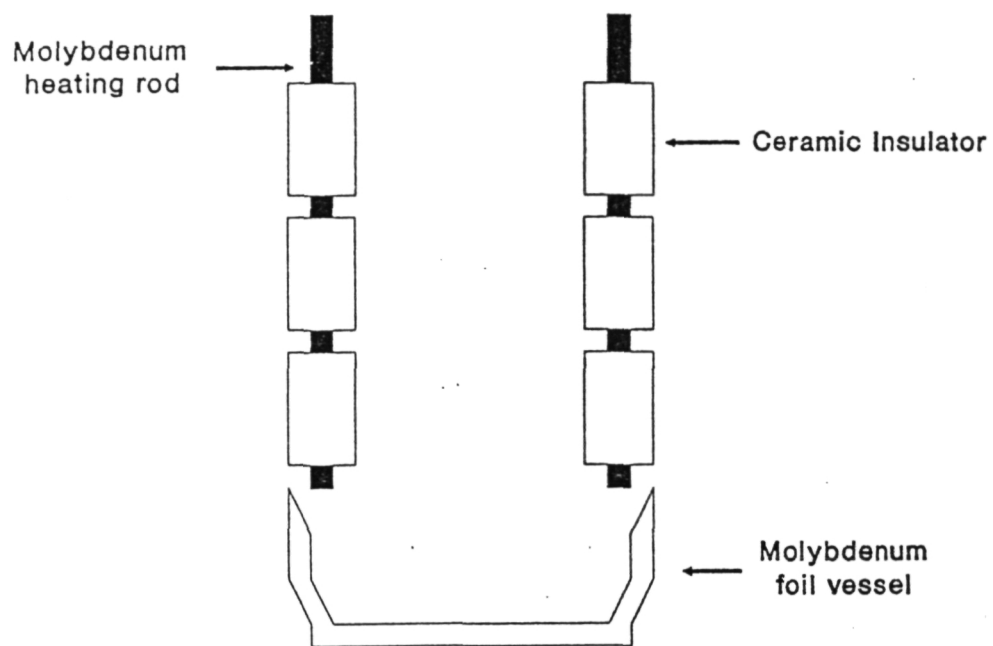
Figure 2. Enlarged schematic of molybdenum boat and electrical connections within the reaction retort.

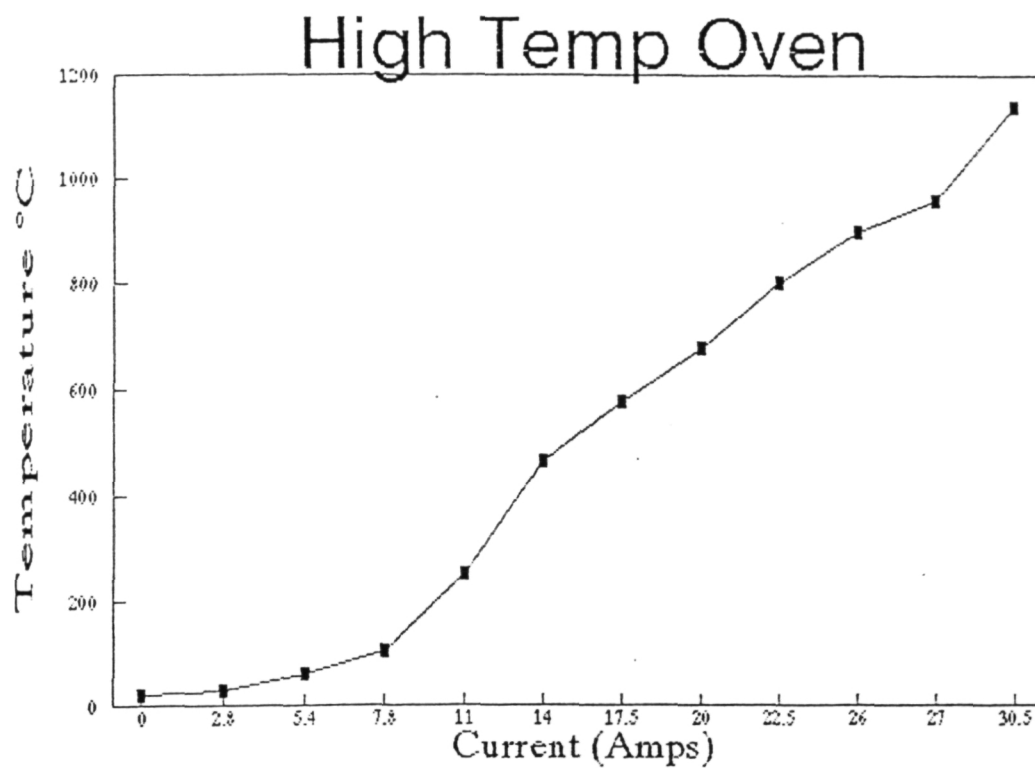
Figure 3. Reaction temperature as a function of the input current for the retort.

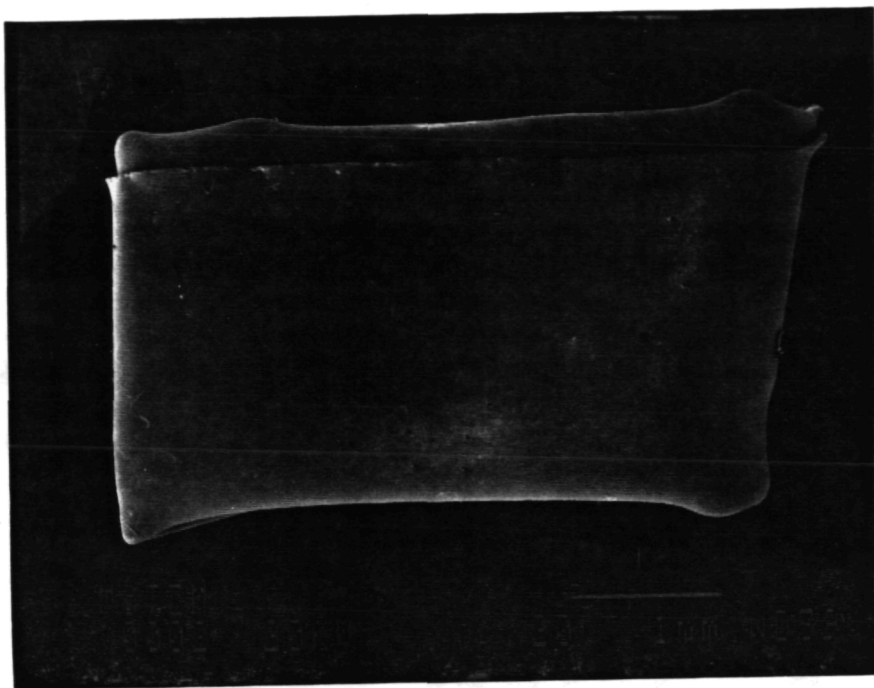
Figure 4. Molybdenum foil container.

The first type of sample used consisted of a container of molybdenum foil folded tightly around a piece of TZM and several pieces of GaAs (Figure 4). In all cases the amount of GaAs used was 3 to 10 mg and the TZM was 5 to 7 mg. The rest of the sample weight consisted of the Mo-foil wrapping. The four samples tested are listed in Table 1.

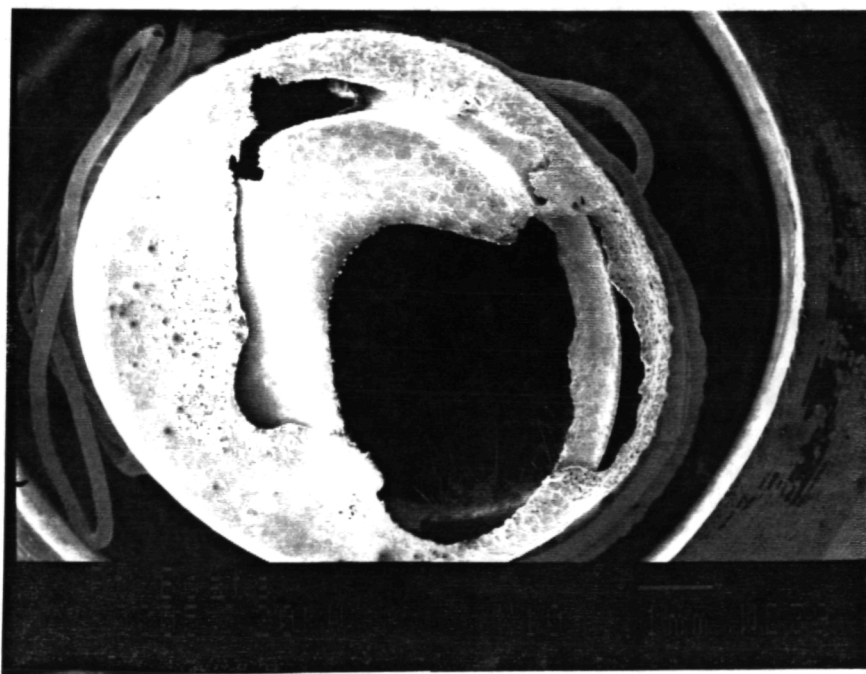
Figure 5. Platinum boats showing attack by gallium.

In sample MOTZM, no attack of the Mo foil and the Pt boat occurred and no reaction between the atmosphere and the TZM was observed. However, for TA1 and TA2, a hole must have been punched in the Mo foil during the wrapping of the sample. In each case the hole allowed the molten Ga to reach and react the Pt boat. The bottom of the boats were dissolved away thus dropping the sample out of the hot zone of the vertical furnace terminating the run (Figure 5).

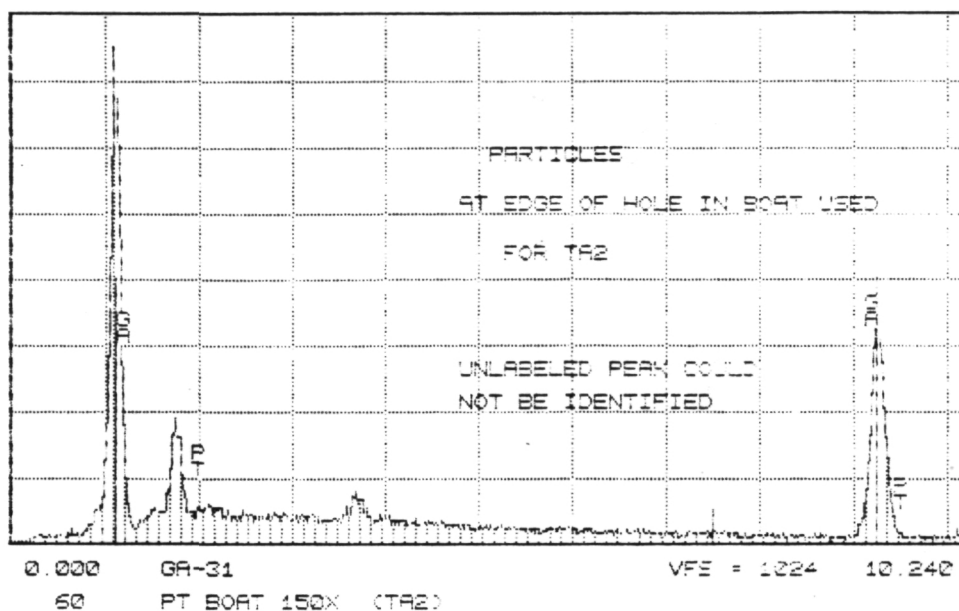
Figure 6. EDX spectrum from Ga particles shown in Figure 5.

Results of this type of experiment indicated that the GaAs decomposes into arsenic vapor and "molten" gallium at the temperatures involved. This produced two consequences. First, all the arsenic vaporized out and was lost to the system. X-ray analysis revealed no arsenic present after any of these runs. Second, the molten gallium tended to escape from the container and very vigorously attacked and dissolved the "non-reactive" platinum crucible (Figure 5). The presence of gallium on the remains of the platinum crucibles was found by x-ray analysis (Figure 6).

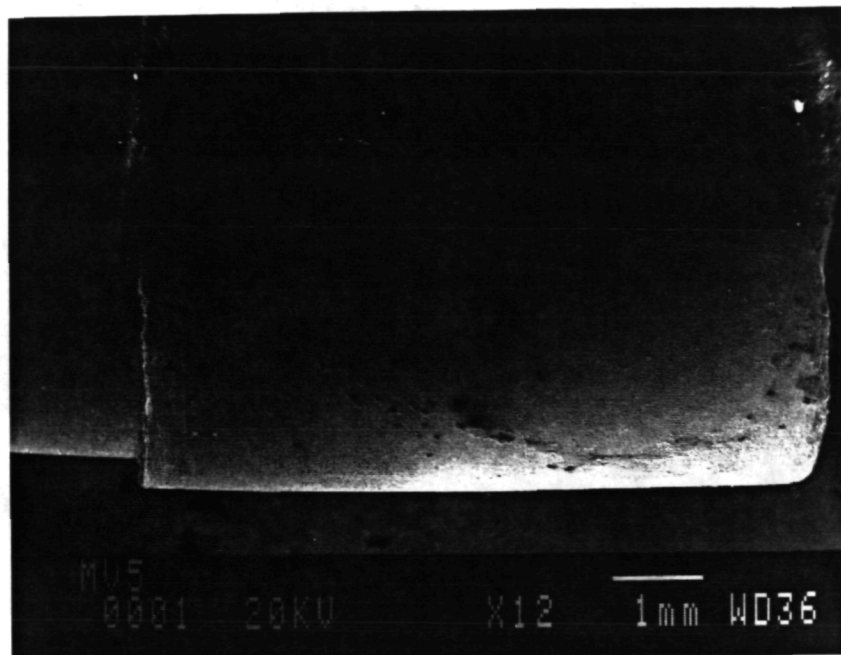
Figure 7. General view of molybdenum cylinder with plug after 24 hour reaction with GaAs.

Figure 11 shows the plug end of the cylinder from Figure 7. No cracks in the molybdenum cylinder were evident in either Figure 7 or Figure 11. Tungsten was found on the outer surface of the cylinder after treatment (Figure 12). This tungsten is the result of vaporization of the tungsten wire-basket.

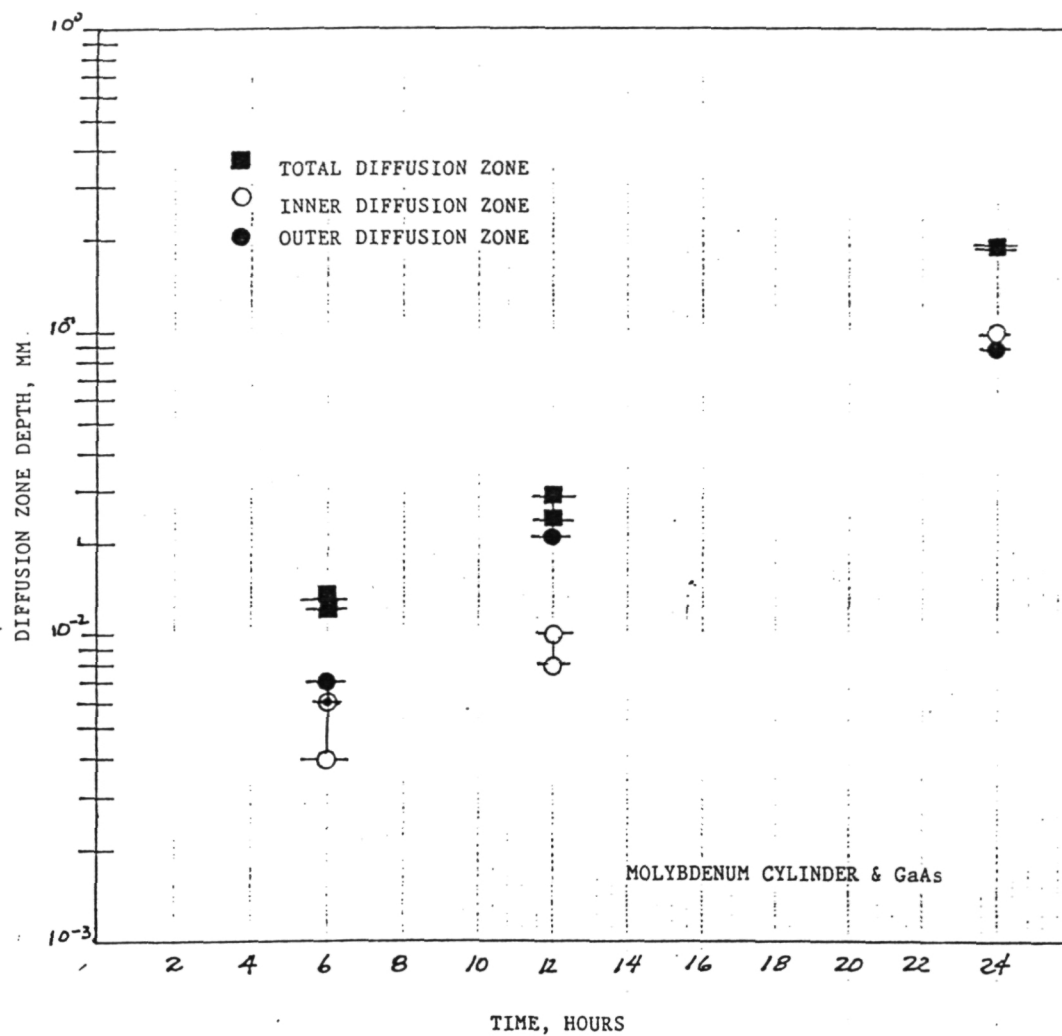
Figure 8. Depth of reaction (diffusion) zone in the molybdenum cylinder.

Note that Figures 8 and 9 are plots of log depth vs. linear time. The data does not fit a standard log-log plot and, thus, does not seem to adhere to the standard square root of Dt diffusion law (D is the diffusion coefficient and t is time). This may be the result of cracking of the diffusion zone every 0.05 to 0.25 mm along its length. This cracking extends through the diffusion zone to the base metal as shown in Figure 10. This cracking should allow new reaction surfaces to be present at all times thus increasing the reaction rate.

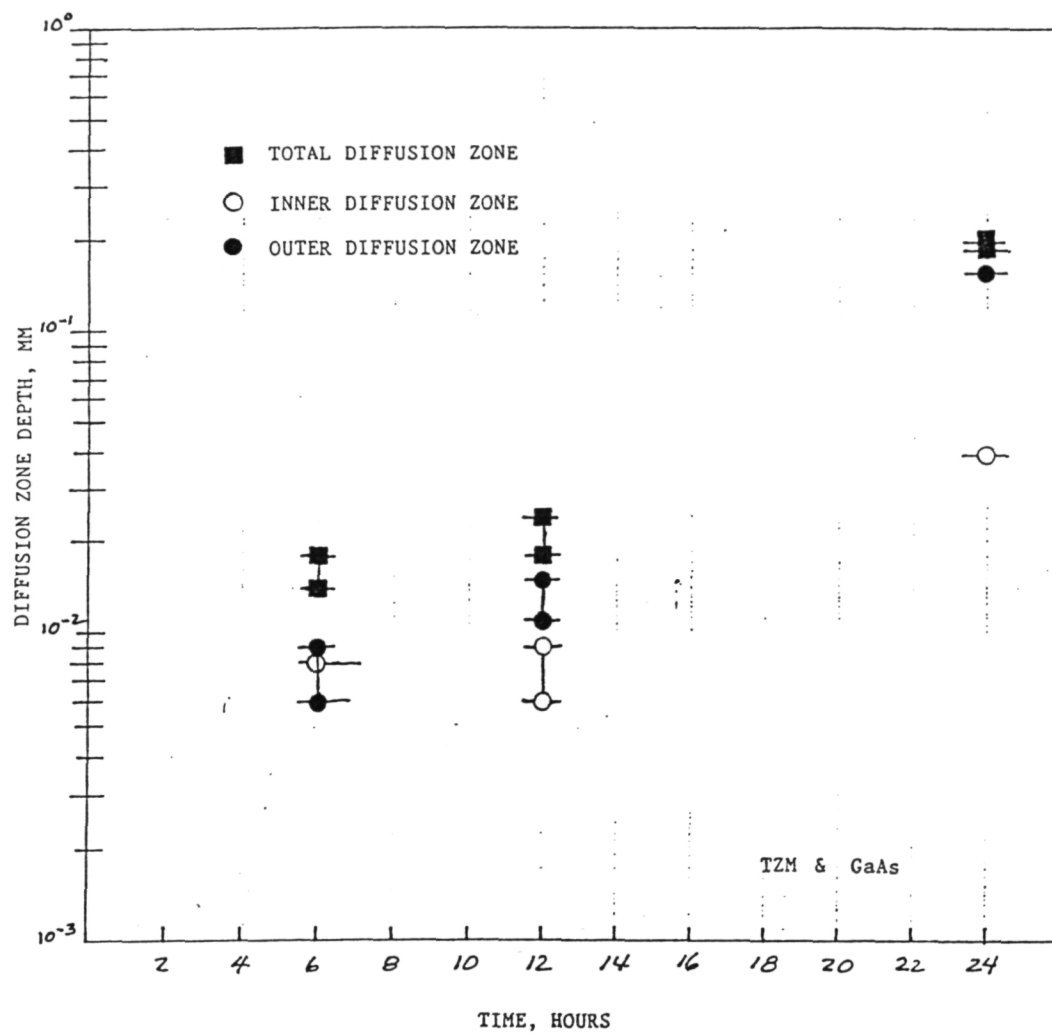
Figure 9. Depth of reaction (diffusion) zone in the TzM with GaAs.

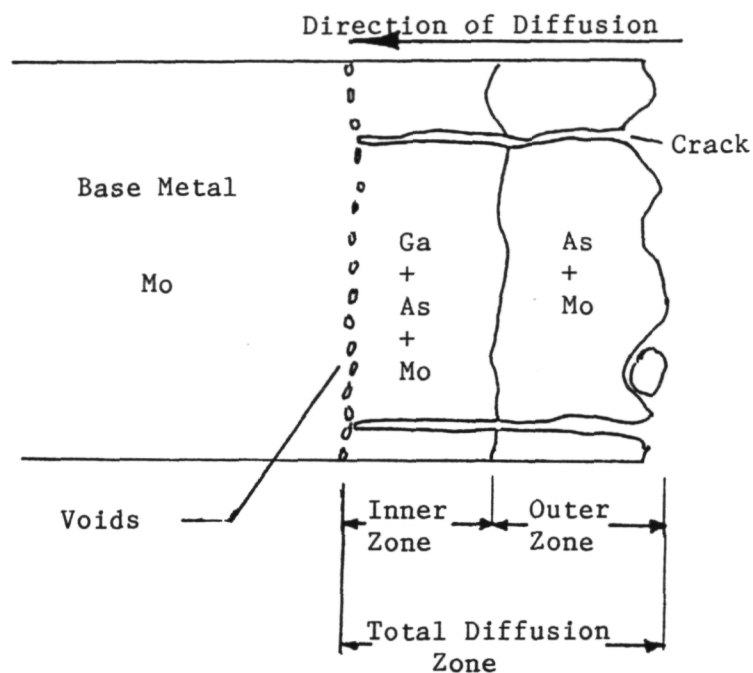
Figure 10. Reaction regions found after the reaction of GaAs with either molybdenum or TZM.

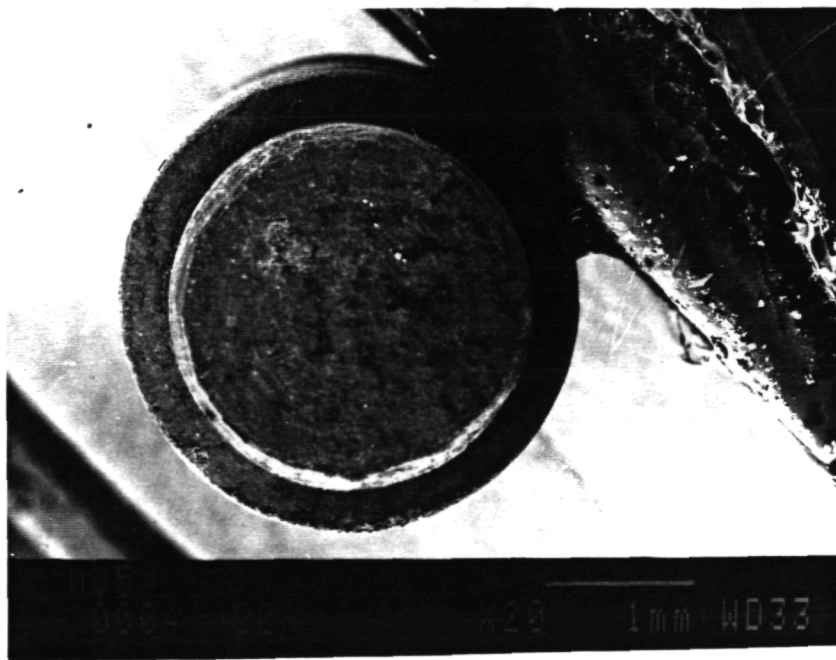
Figure 11. General view of plug end from Figure 7.

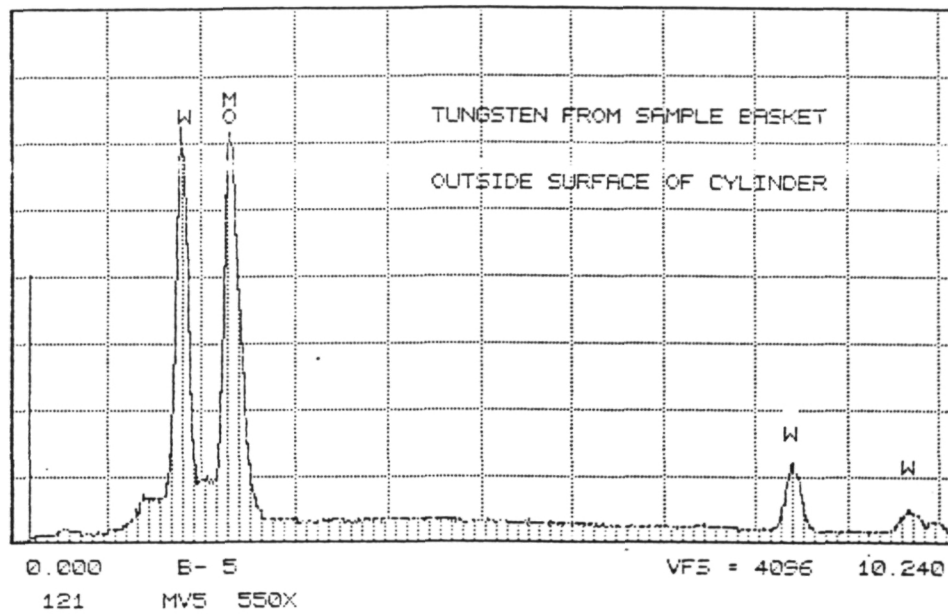
Figure 12. EDX spectrum of outside cylinder surface.

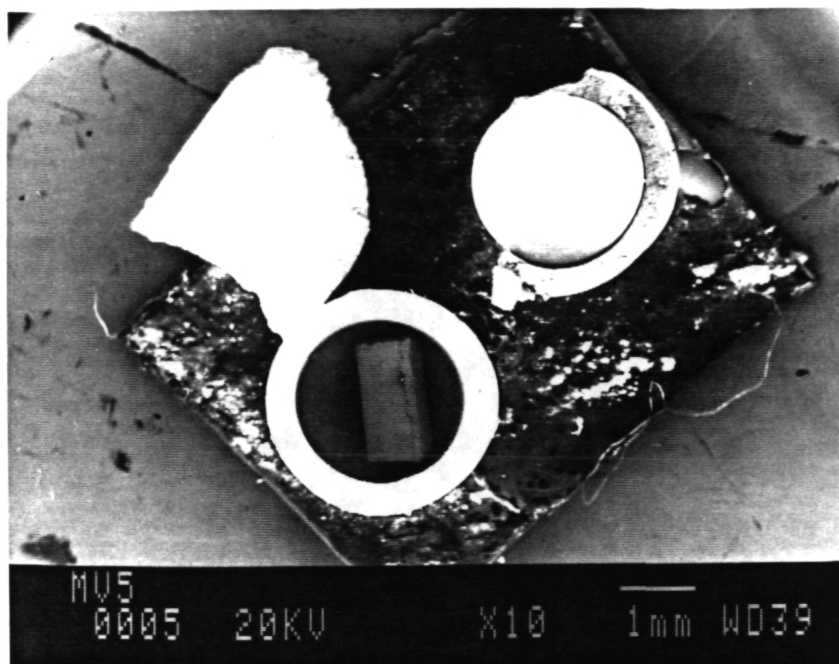
Figure 13. View of reacted cylinder after being mechanically broken apart.

a. Molybdenum and GaAs: To analyze what occurred between the TZM and GaAs (also between molybdenum and GaAs), the cylinder was broken open mechanically. The cylinder fractured in a brittle manner as can be seen in Figure 13. This figure shows the bottom end of the cylinder, the bottom of the plug and part of the cylinder wall from the top portion of the cylinder.

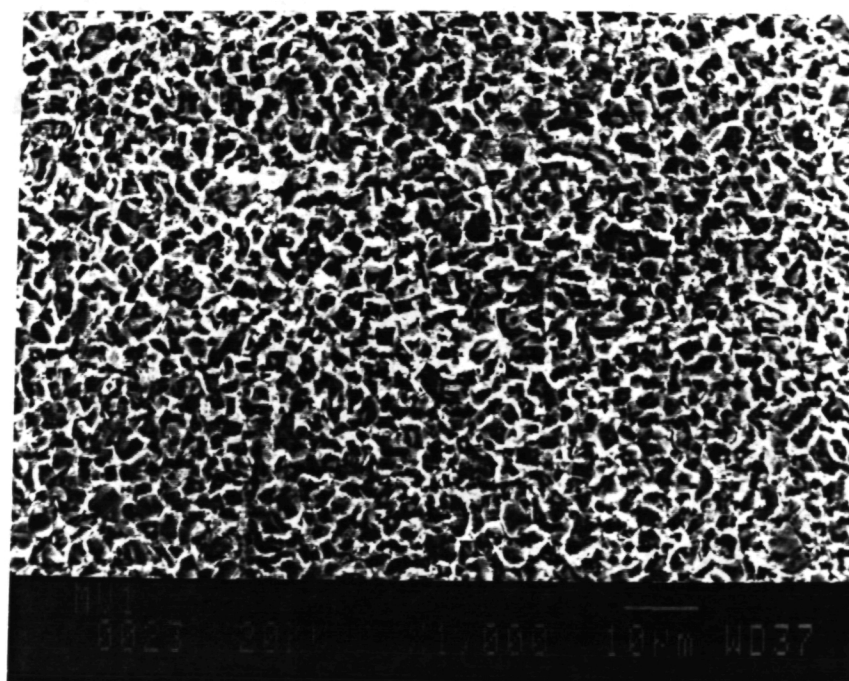
Figure 14. Surface of bottom of a molybdenum cap after 24 hour treatment without GaAs.

Figure 14 shows the microstructure of the bottom of a plug used in a cylinder which was tested without GaAs. Oxidation of the cap and the presence of small size porosity voids can be seen. Figure 15 is the x-ray spectrum taken from the surface in Figure 14. Only molybdenum was found. Figure 16 shows the microstructure of the bottom of the plug from Figure 13. The molybdenum of the plug has been attacked as can be seen by the grain structure. EDX analysis of the cap showed molybdenum and arsenic (Figure 17). However, two somewhat larger crystals can be seen in the center of Figure 16. Both of these crystals were found to be gallium (Figures 18 and 19). The x-ray spectrum (Figure 20) from the region between the two particles again indicates molybdenum and arsenic.

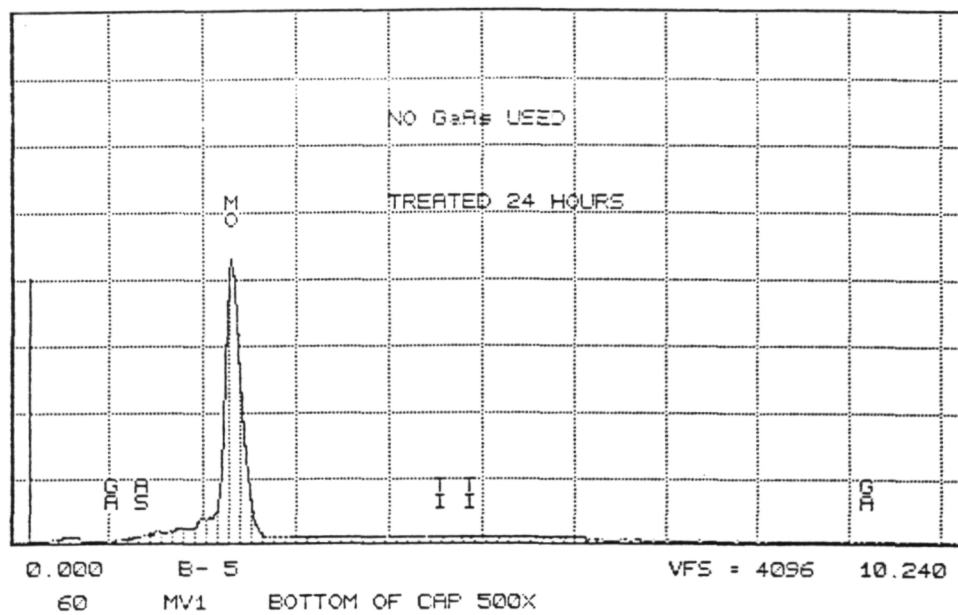
Figure 15. EDX spectrum of surface shown in Figure 14.

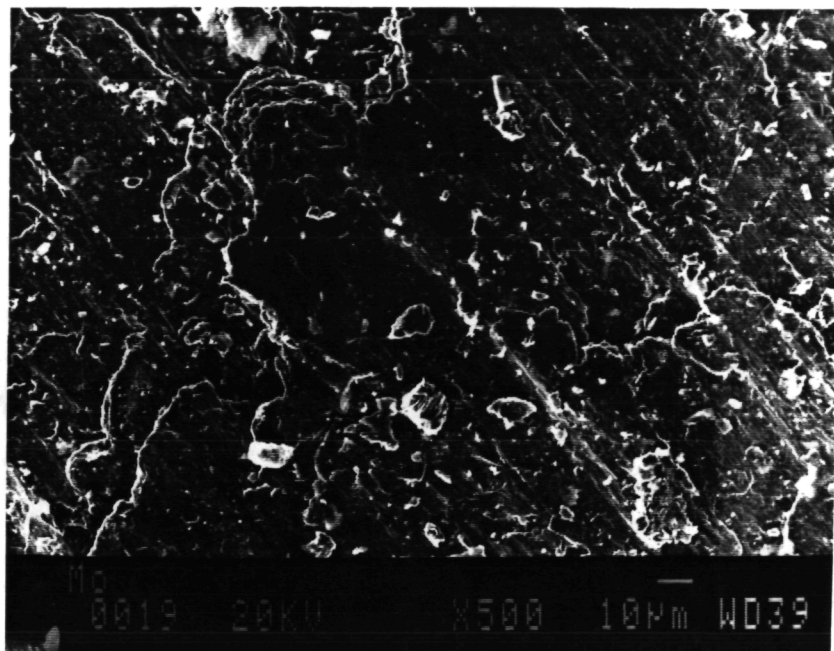
Figure 21. Wall surface of unused molybdenum cylinder.

The structure of the inside wall surface of an unused (not heated) molybdenum cylinder is shown in Figure 21. This is a "machined" surface. The x-ray spectrum for this material is found in Figure 22. The structure of the inside cylinder wall after reacting with GaAs is shown in Figures 23 and 24. Comparison of Figures 23 and 24 with Figure 21 indicates that some reaction occurred between the molybdenum cylinder and the GaAs. EDX analysis of the inside surface of the cylinder wall shown in Figure 13 revealed only molybdenum (Figure 25) at the end which was in contact with the end plug and, therefore, was protected from the

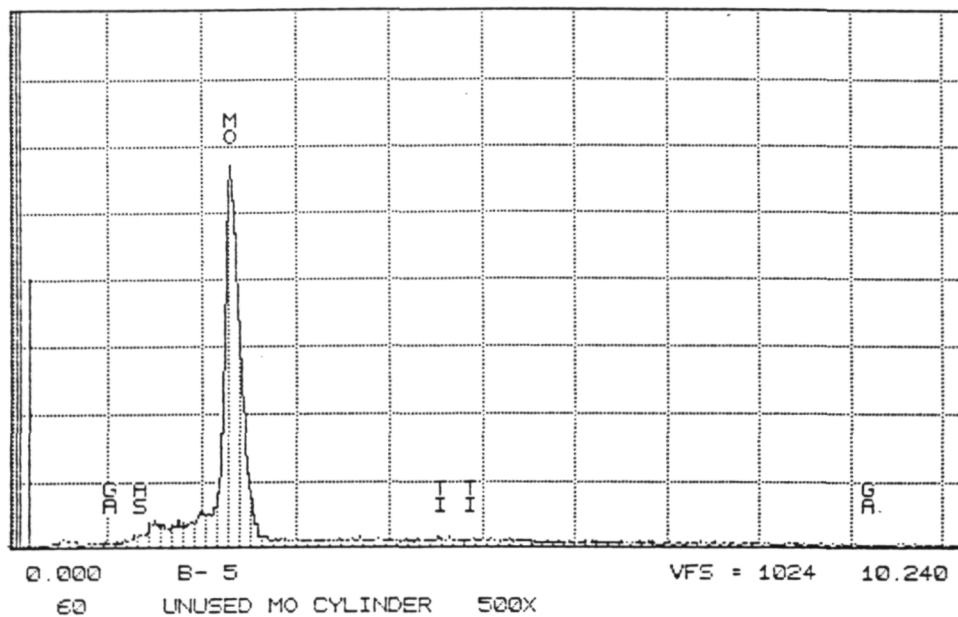
Figure 22. EDX spectrum of surface from Figure 21.

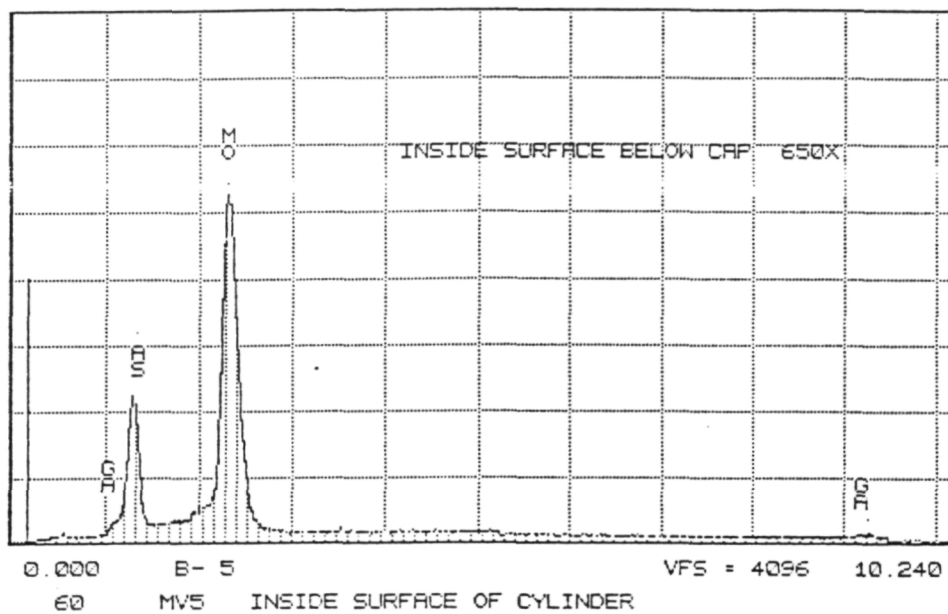
Figure 26. EDX spectrum from wall at region below the cap.

GaAs. Further down the wall, arsenic was found again (Figure 26). No gallium was found.

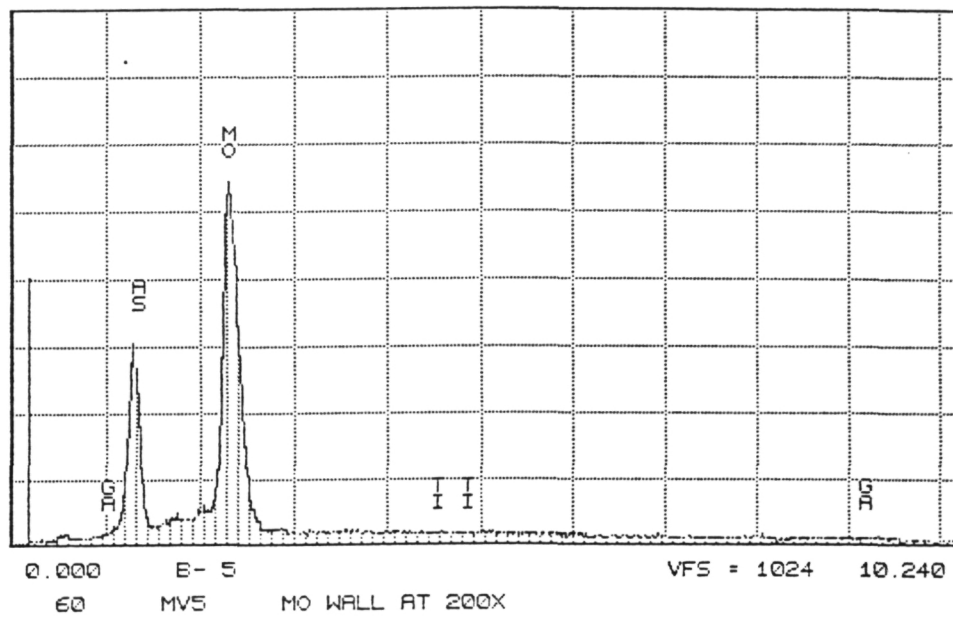
Figure 27. EDX spectrum from wall in region of Figure 23.

The general x-ray spectrum of the molybdenum cylinder wall from the area of Figure 23 is shown in Figure 27. Again, only molybdenum and arsenic were detected. However, x-ray spectra of various particles seen in Figure 23 revealed the presence of other elements. Some of these very small particles contained tungsten (Figure 28). Actually, the particles were small enough so that the beam penetrated to the underlying wall where the molybdenum and arsenic peaks were produced. The particles very likely are tungsten oxide dust which was torn loose from the outside cylinder surface when the cylinder was mechanically broken open.

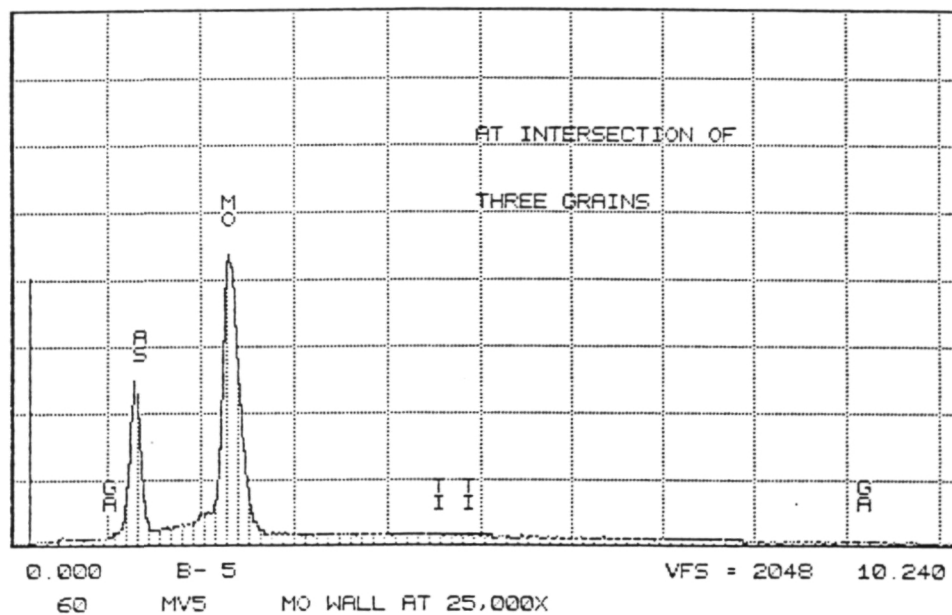
Figure 29. EDX spectrum from the intersection of three grain in wall surface.

In an effort to find gallium on the wall surface, an x-ray spectrum was produced at a magnification of 25,000X at the intersection of three grains. This spectrum is shown in Figure 29. Gallium was not detected in the grain boundary region. Another region of the wall was then analyzed (Figure 30). Considerable porosity along with small particles were found. EDX analysis of some of these particles revealed the presence of both gallium and titanium (Figure 31). The titanium must be the result of the presence of TZM within the cylinder.

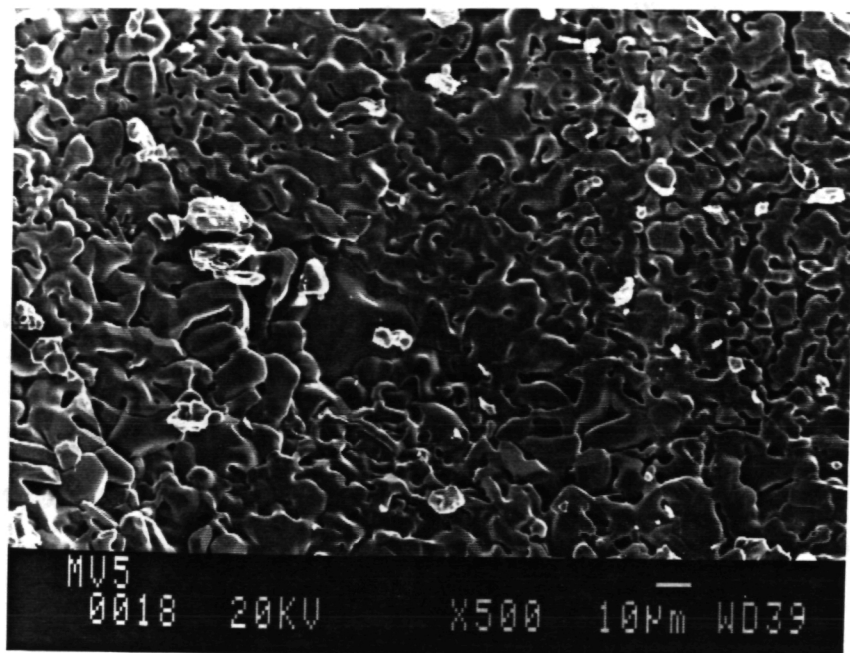
Figure 32. Structure at the bottom of the reacted cylinder.

The structure at the bottom of the molybdenum cylinder (Figure 32) again indicates that a reaction occurred between the molybdenum and the GaAs. An x-ray spectrum (Figure 33) of the cylinder bottom shows the presence of mainly molybdenum. The tungsten if present would be dust as explained above. Various types of particles were found on the cylinder bottom. Some were molybdenum (Figure 34); some contained

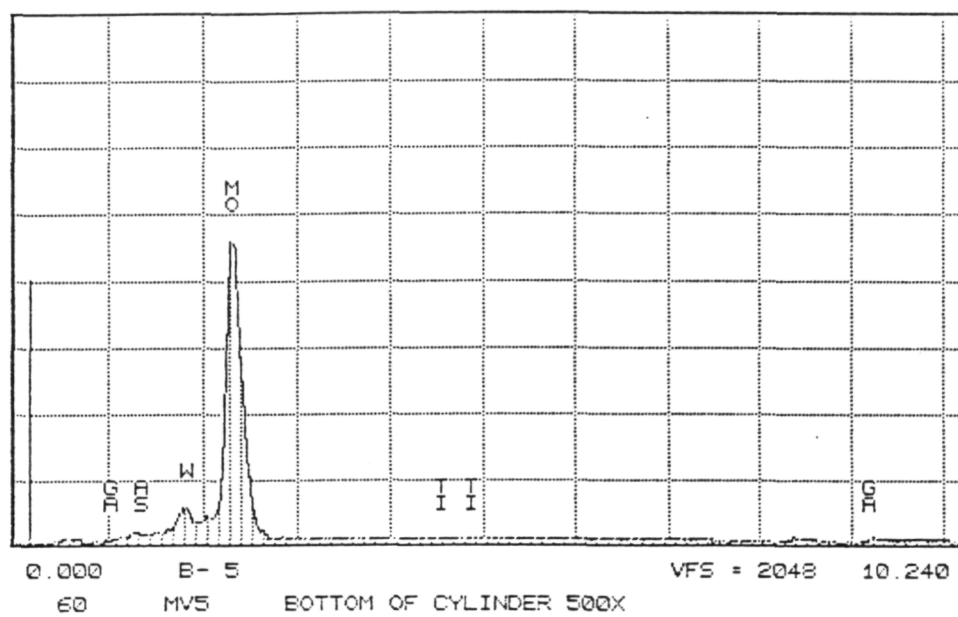
Figure 33. EDX spectrum from bottom of cylinder.

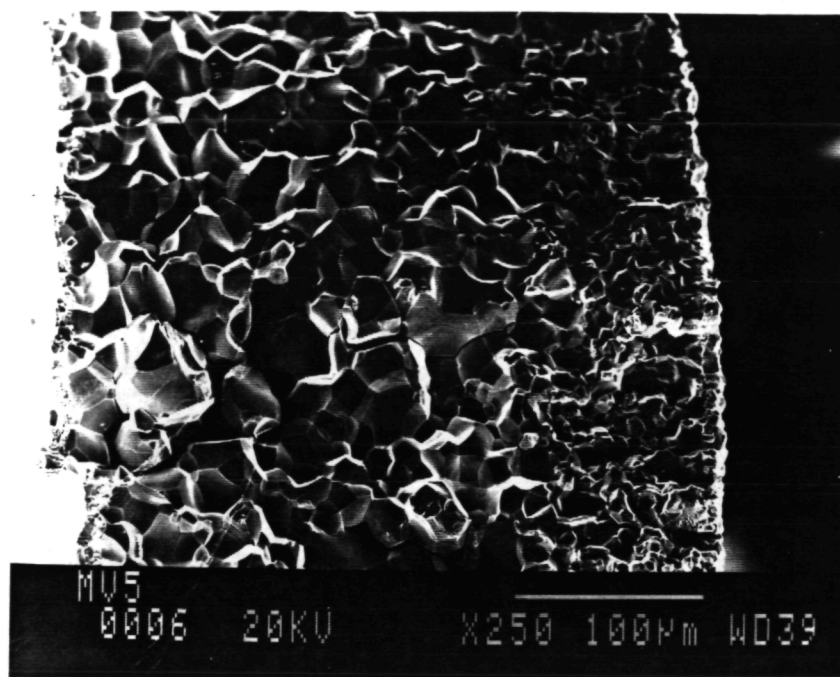
Figure 37. Fracture surface of wall after mechanical breakage. The outside surface is to the right.

Figure 37 shows the brittle fracture surface of the cylinder wall resulting from mechanically breaking the cylinder. Three zones in the wall are evident from this figure. The first zone at the outside surface shows a fine grain structure and is about 100 μm thick. EDX analysis revealed that this zone contained both molybdenum and tungsten (Figure 38). The second zone contains a large grained microstructure consisting of only molybdenum (Figure 39). The third zone is about 10 μm thick at the inside wall of the cylinder. EDX analysis of this very fine grained region showed the presence of some arsenic (Figure 40).

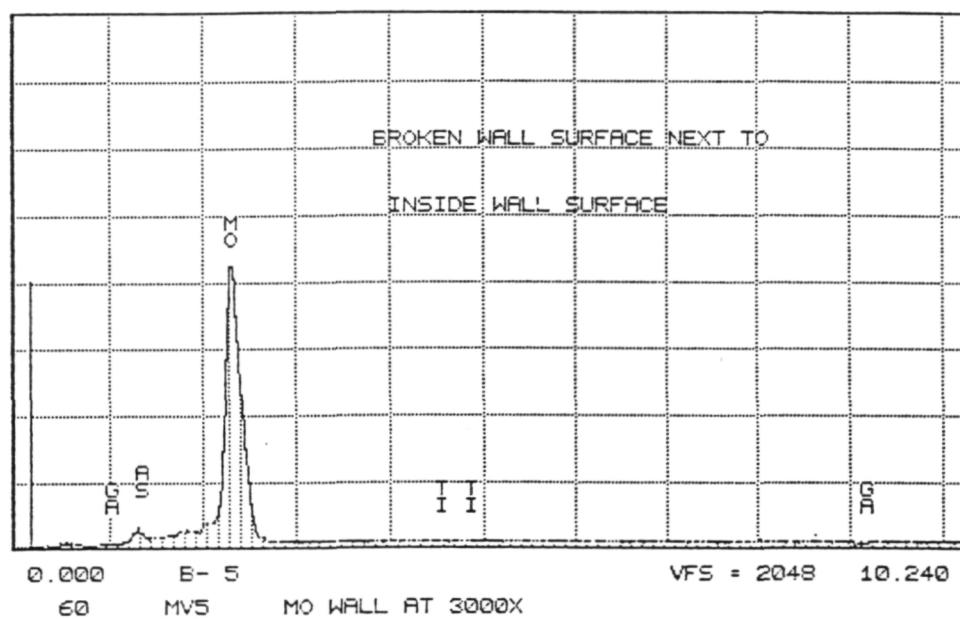
Figure 40. EDX spectrum at region on inside surface of the fracture shown in Figure 37.

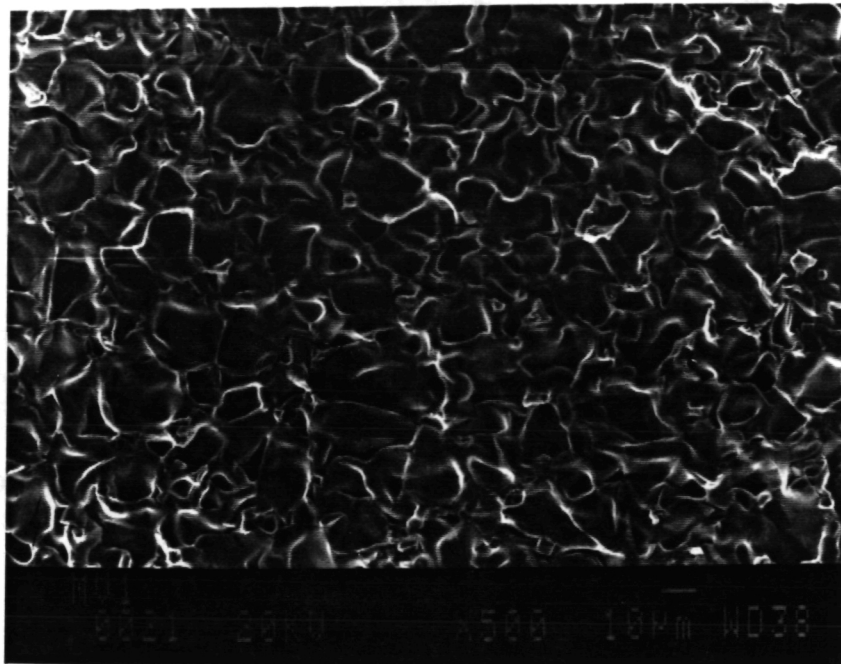
Figure 41. Structure of TZM treated for 24 hours without GaAs.

b. TZM and GaAs: The reaction between TZM and GaAs was very similar to that between molybdenum and GaAs. The microstructure (Figure 41) and the x-ray spectrum (Figure 42) of TZM heated for 24 hours without the presence of GaAs are given for comparison purposes. Only the molybdenum peak is evident. The TZM after reacting with GaAs is shown in Figure 43 while Figure 44 shows the microstructure of this TZM. EDX analysis of the surface (Figure 45) revealed some gallium along with titanium. Titanium was found only in the x-ray spectrum after the surface reaction with GaAs.

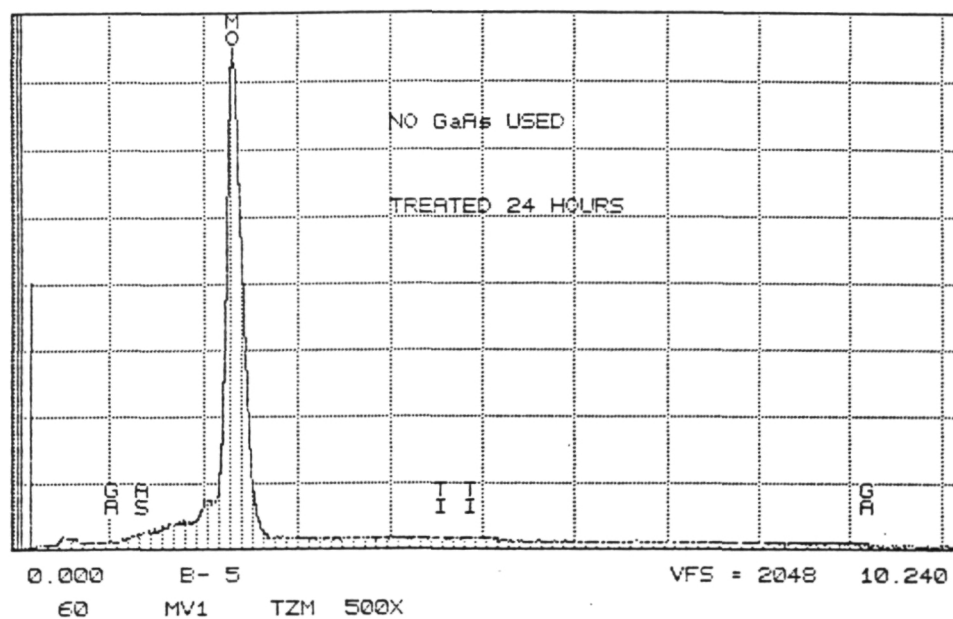
Figure 42. EDX spectrum from surface of TZM treated 24 hours without GaAs (from Figure 41).

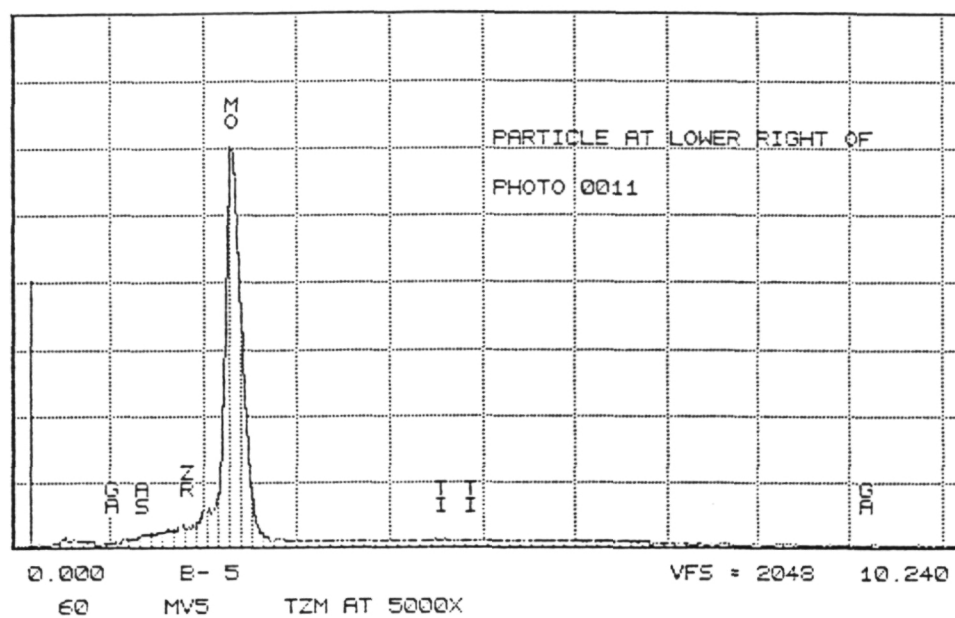
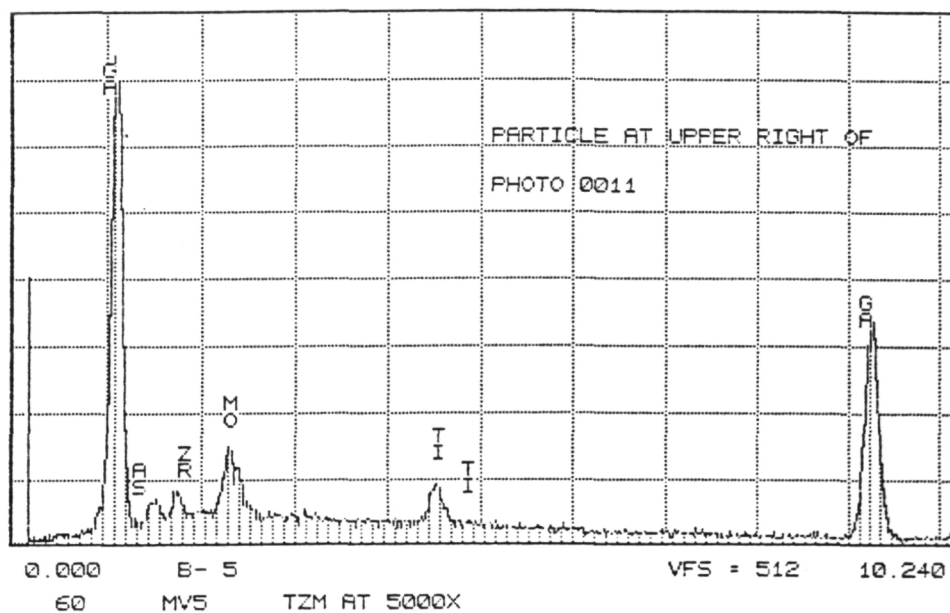
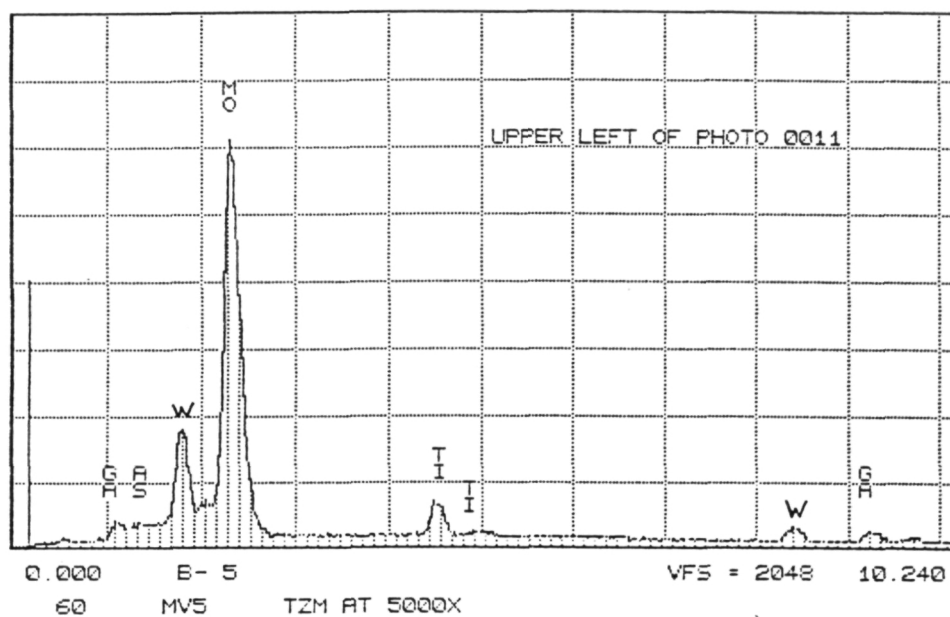
Figure 46. EDX spectrum from particle at lower right of Figure 44.

Figure 47. EDX spectrum from particle at upper right of Figure 44.

Figure 48. EDX spectrum from particle at lower left of Figure 44.

Figures 46, 47 and 48 are x-ray spectra of particles shown in Figure 44. These particles ranged from pure molybdenum (TZM) to high concentrations of gallium. The microstructure in Figure 49 is a high magnification of the center of Figure 44. The x-ray spectra from three

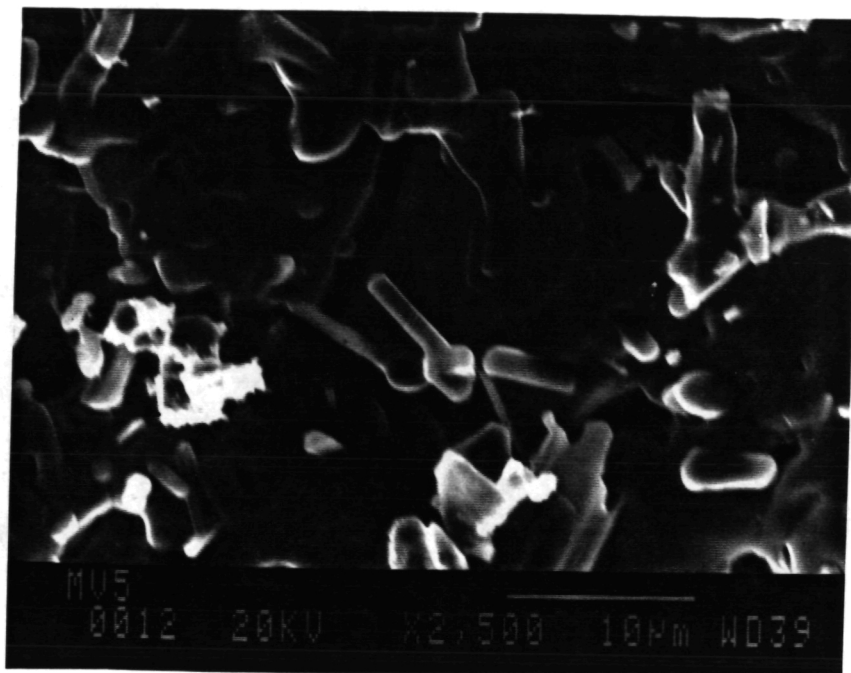
Figure 49. High magnification of center region of Figure 44.

particles shown in Figure 49 are given in Figure 50, 51 and 52. All of the particles contained gallium and titanium. However, when x-ray analysis (Figure 53) was performed of the matrix (a grain) from the center of Figure 49 only a molybdenum peak was found.
